FRP gratings and handrails : in chemical industry

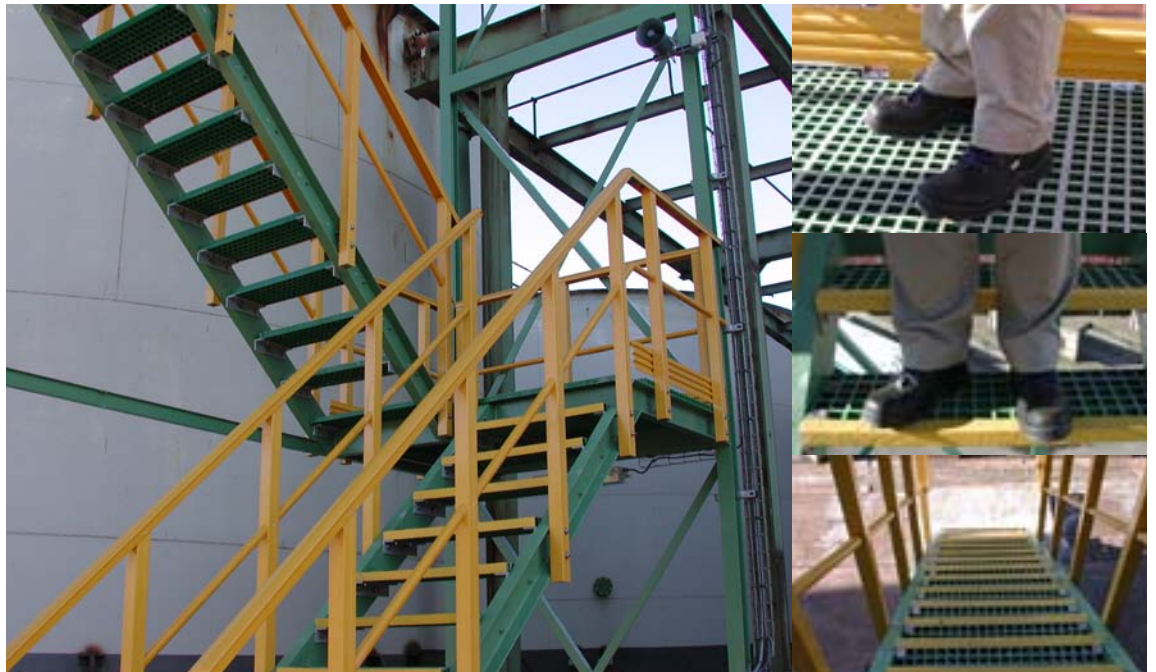
- Problem** The steel access tower nearby a salt production unit had serious corrosion problems. Handrails were strongly corroded (several connections no longer existed) and the wooden stair steps were slippery and rotten.
- Solution** Vink engineers examined the site and convinced the customer to use FRP handrails and molded gratings.
- Materials**
- Vikugrate Stair treads and gratings
 - FRP handrail system :
 - box 60 x 60 x 4.5
 - handrail profile
 - kneerail 38 x 32
 - kickplate W150/3
- Year of construction** 2002
- Benefit**
- corrosion free material
 - yellow colour for the handrails increases safety
 - no more painting in the future by using FRP
 - outstanding antiskid properties of the gratings (R13 – V10 according to DIN 51 130)
 - VCA certified installation team
