FRP constructions: Staircase tower nearby cooling tower.

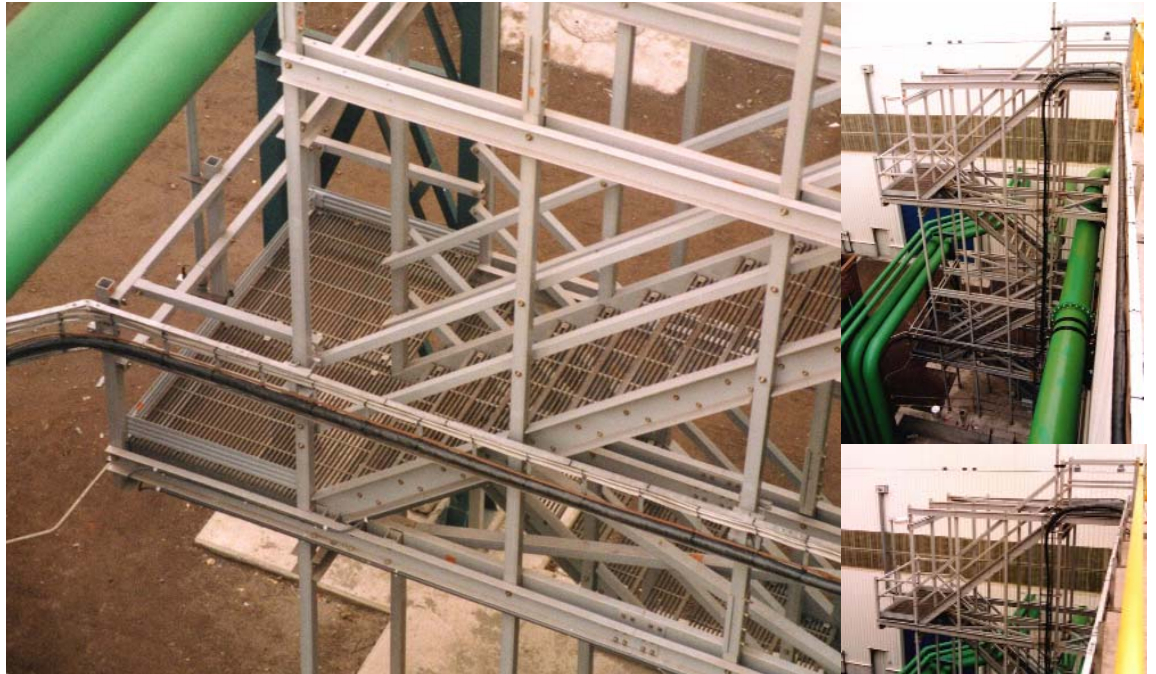
- Size** the tower is 12m high, used profiles:- Box 75 x 75 x 6
 - Box 60 x 60 x 4.5
 - U 200/80/8
 - U 150/50/6
- Year of construction** 2001
- Benefit** FRP materials are the ideal solution for your corrosion problems. Beside the light weight the materials offer low maintenance costs since they are colored in mass. They do not need painting. The material is non conductive and non magnetic. It has no plastic deformation and is thermally stable.

- Problem** Nearby cooling towers, the secondary equipment (handrails, ladders, gratings, internal walkways,...) are subjected to heavy corrosion. Traditional materials such as galvanized steel and wood need severe maintenance.

- Solution** In order to deal with corrosion, low maintenance cost and ease for installation Fiber Reinforced Plastic beams and gratings are used. They are the ideal material to withstand corrosion. They do not rust and are not attacked by bacteria's.
