FRP constructions: Stair case in a swimming pool

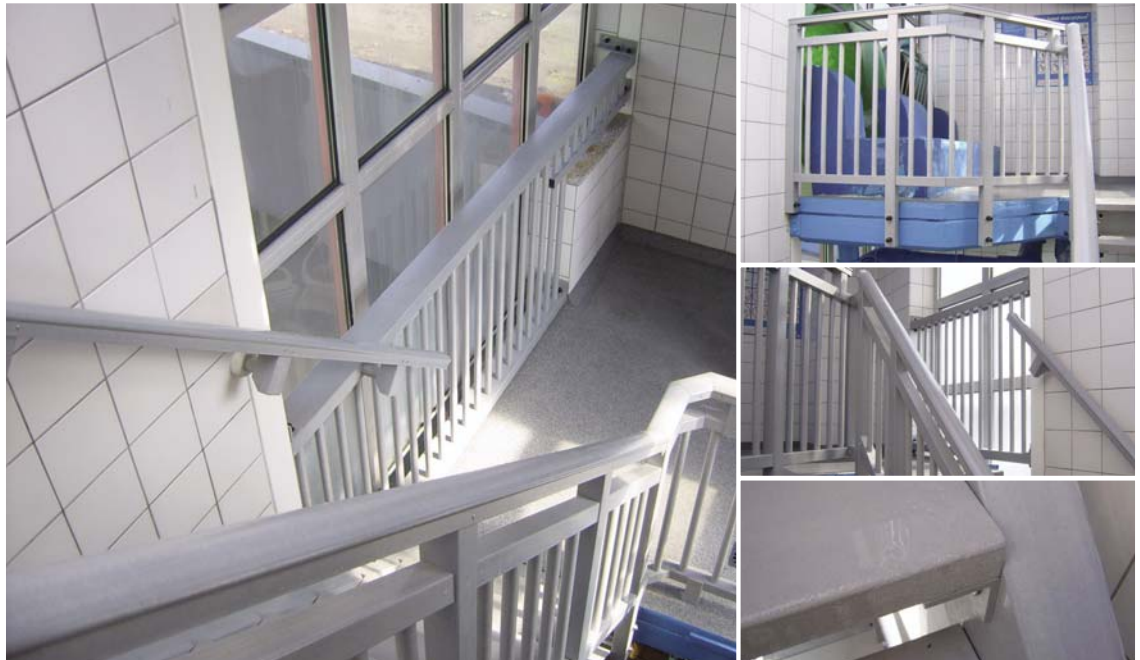
Problem	Swimming pools are often confronted with severe corrosion problems. Most of all in these areas were splashes of water get into contact with steel parts. In order to access a giant slide, a steel stair case was built several years ago and became insecure due to corrosion for public access.
Solution	In order to deal with this corrosion problem Fiber Reinforced Plastic beams and covered gratings were used. They are the ideal material to withstand this chlorine environment. They do not rust and are not attacked by bacteria's. They are easy to clean and the stair treads are foreseen with an adequate grit surface to prevent slipping.
Size	4 stairs with each 10 steps, handrails on both sides with vertical tubes as spacer.
Material	U 200/80/8 L60/60/8 Handrail system containing: square box 60*60*4.5 and 51*51*3.25, tube 30*24 and ergonomic handrail Vikugrate covered grating.
Year of construction	beginning of 2009.

Benefit	FRP materials are the ideal solution for your corrosion problems. Beside the light weight the materials offer low maintenance costs since they are colored in mass. They do not need painting. It has no plastic deformation and is thermally stable. It is safe in use thanks to the grit surface.
