FRP constructions: Vinylester walkways in an electrolysis.

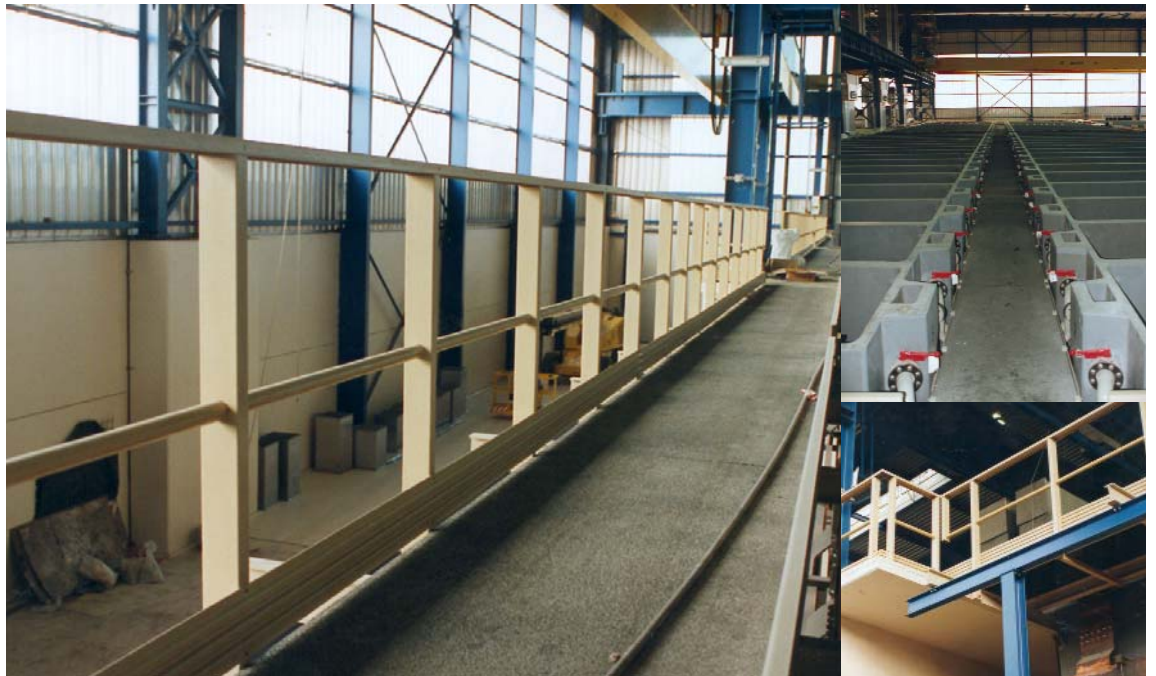
Problem	In the copper electrolysis of Cumerio, the environment is very corrosive. The electrolyte contains 200 g/l H_2SO_4 at 65°C. Between the cells, walkways including handrails needed to be installed at 5m height.
Solution	Vinylester resin offers an outstanding corrosion resistance to the electrolyte. The Vikugrate gratings have a covered top plate with grit.
Size	1000m ² of Vikugrate with 4000m of supporting profiles and 200m of handrails.
Year of construction	1996 and 1997
Benefit	FRP materials are the ideal solution for your corrosion problems. Beside the light weight the materials offer low maintenance costs since they are colored in mass. They do not need painting. The material is non conductive and non magnetic. It has no plastic deformation and is thermally stable.
