FRP constructions: Internal walkways for pump rooms of lock gates

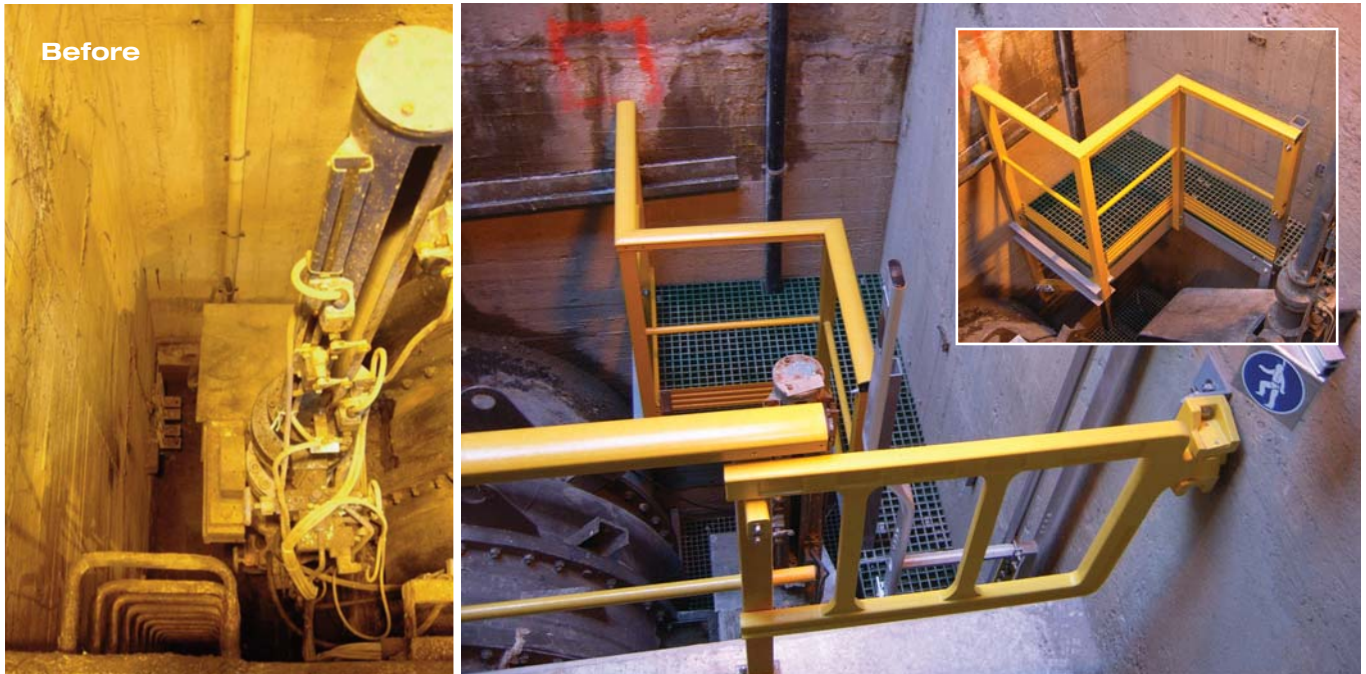
Problem	The steel, internal walkways of the pump rooms of several lock gates on the river 'Samber' showed severe corrosion problems and needed to be replaced and modified in order to meet all present safety regulations.
Solution	The customer was looking for a material that was corrosion resistant and colored in mass, in short a material needing virtually no maintenance. Furthermore the materials needed to meet the strict safety and strength regulations for a lasting performance. Composite profiles and gratings were used to bring the lifetime up and life-cycle-cost down of these constructions.
Materials	U 200/80/8 and U150/50/6 Handrail system: square box 60, kneerail dia. 38mm, handrail and kickplate Vikugrate 38x38xH38mm with grid Security gate: Double gate 81 cm.
Size	18 pump rooms containing each 2 walkways with handrails and security gates.
Year of construction	2008.
Benefit	Today, more and more composite materials are used in aggressive surroundings. The harsher the environment, the more they get used. Where metal profiles have to be maintained and replaced regularly, composites don't need maintenance. To design and fabricate these constructions, several standards are available and applied: EN 13706 for pultrusion profiles, EN ISO 14122 for access structures and the 'Eurocomp Desing Guide' providing design rules for safe constructions.
